HVAC Inspection

113 Sample Rd.
Irmo, SC

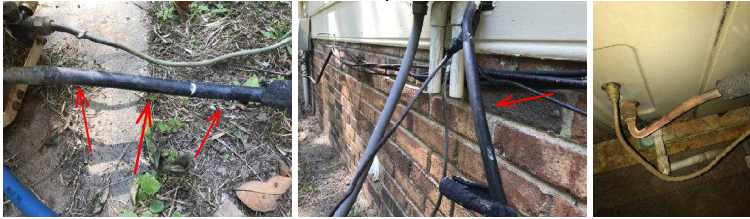
1. Heat Pump AC System Refrigerant Lines: Suction line - The suction line refrigerant line is missing insulation in multiple locations. This can cause condensation and lead to moisture damage. Recommend a licensed HVAC contractor to estimate and repair.
